TOWN OF NANTUCKET NATURAL RESOURCES DEPARTMENT

Draft Pond Management Principles

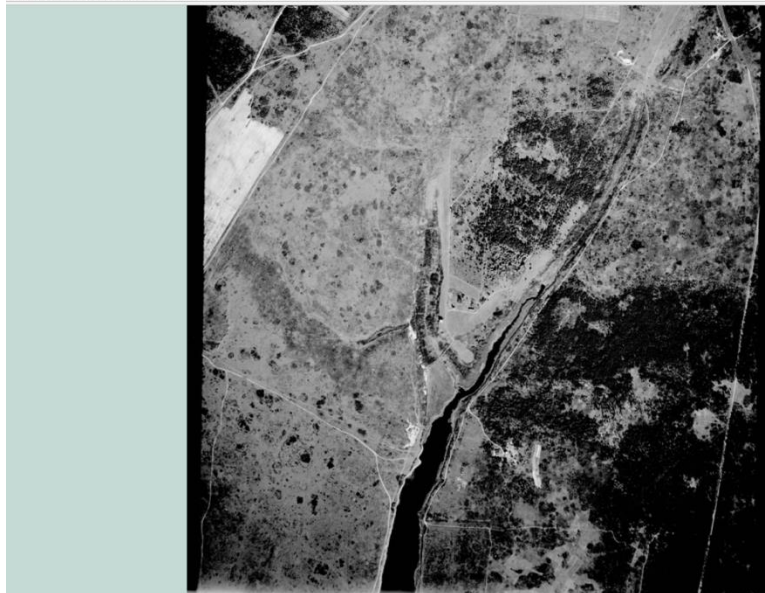
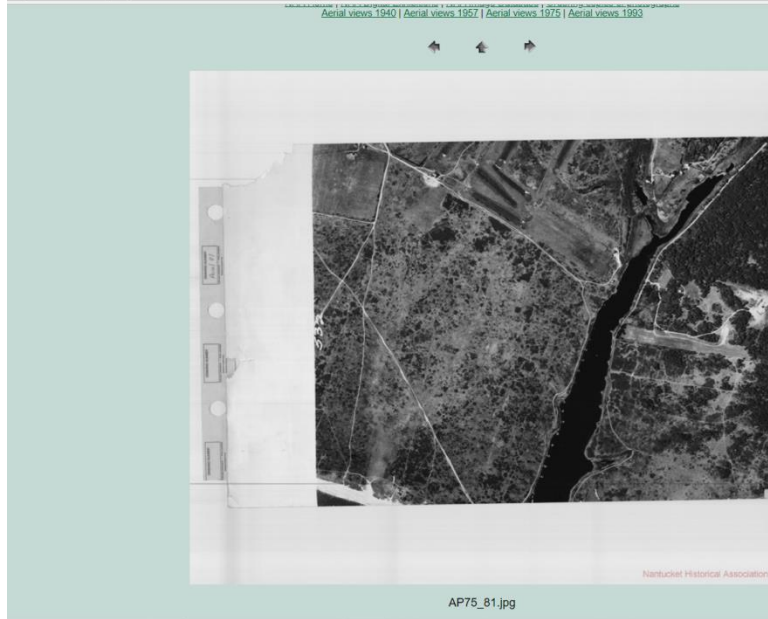
Aerial photos. Nantucket Historical Association 1940 and 1975 aerial photographs of upper reaches of Miacomet Pond which reveal no navigable northern channel existed prior to the 1979 development of this section of Miacomet Ave. Also note, Burchell Pond appeared between 1940 and 1975.
